# THE ENERGY TRANSITION: EXPECTATIONS AND REALITIES IN AFRICA

KAPICHIRA DAM POWER STATION RESTORATION: RECOVERY FROM DISASTER- CEO'S PERCEPTION

ENG. WILLIAM LIABUNYA -EGENCO

6th June 2023

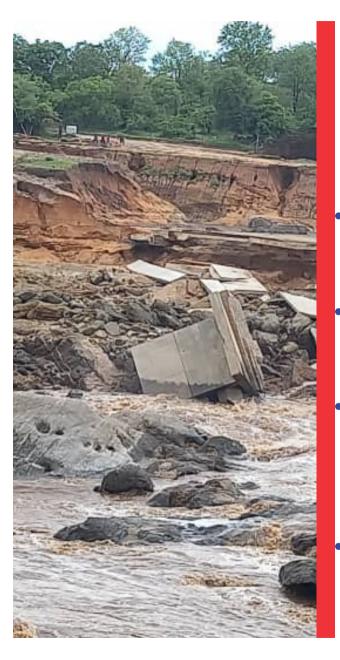
- Cyclone Ana struck the Southern part of Malawi Coming from the Indian Ocean across Mozambique, and affected one of our Hydro Power Station (129.6MW Kapichira Power Station). This was about 1/3 of the Company's installed generation capacity, and approximately 1/4 of the country's installed capacity
- With 30% of Malawi's installed generation capacity lost due to Kapichira being out, this had a significant effect on the national economy. Manufacturing suffered a lot

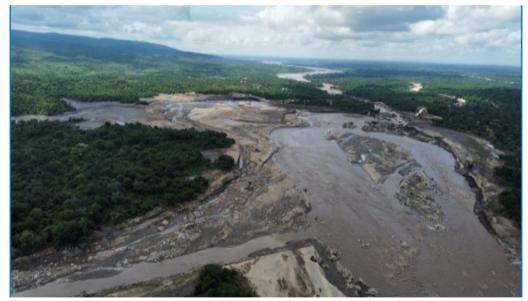
### After

- SVTP (irrigation) intake (under construction was washed away upstream of the fuse
- Restricted fuse plug and inadequate spillway gates were operational prior to the cyclone
- Training Dike & Dam fuse were breached left side of the dam (active storage zone) silted up and flow to its intake was curtailed
- Power station access road was washed away in three sections

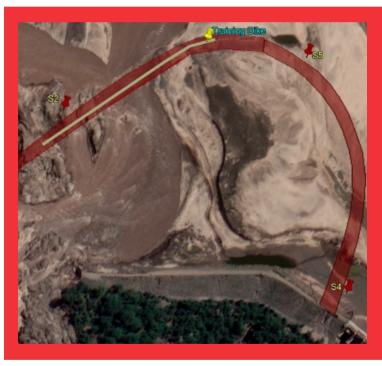
### **Recovery Option A**

- Construction of random earth-fill Cofferdam (1000m long, 25m wide from an elevation of 132m.a.s.l. to 149m.a.s.l., rebuilding training dyke and upgrading of the Stage 1 Cofferdam)
- Repairing of the spillway gates
- Desilting of the left bank channel
- Repair of the eroded d/s and reinforcement of u/s slope of right dam embankment
- Upgrade of cooling water system

Estimated Duration: **7 Months** | Estimated cost **US\$ 14 million**
